# PRO HOME INSPECTIONS LLC

## Property Inspection Report

**Address: 13547 Sample Dr.**

**Inspection date: 07/10/2012**

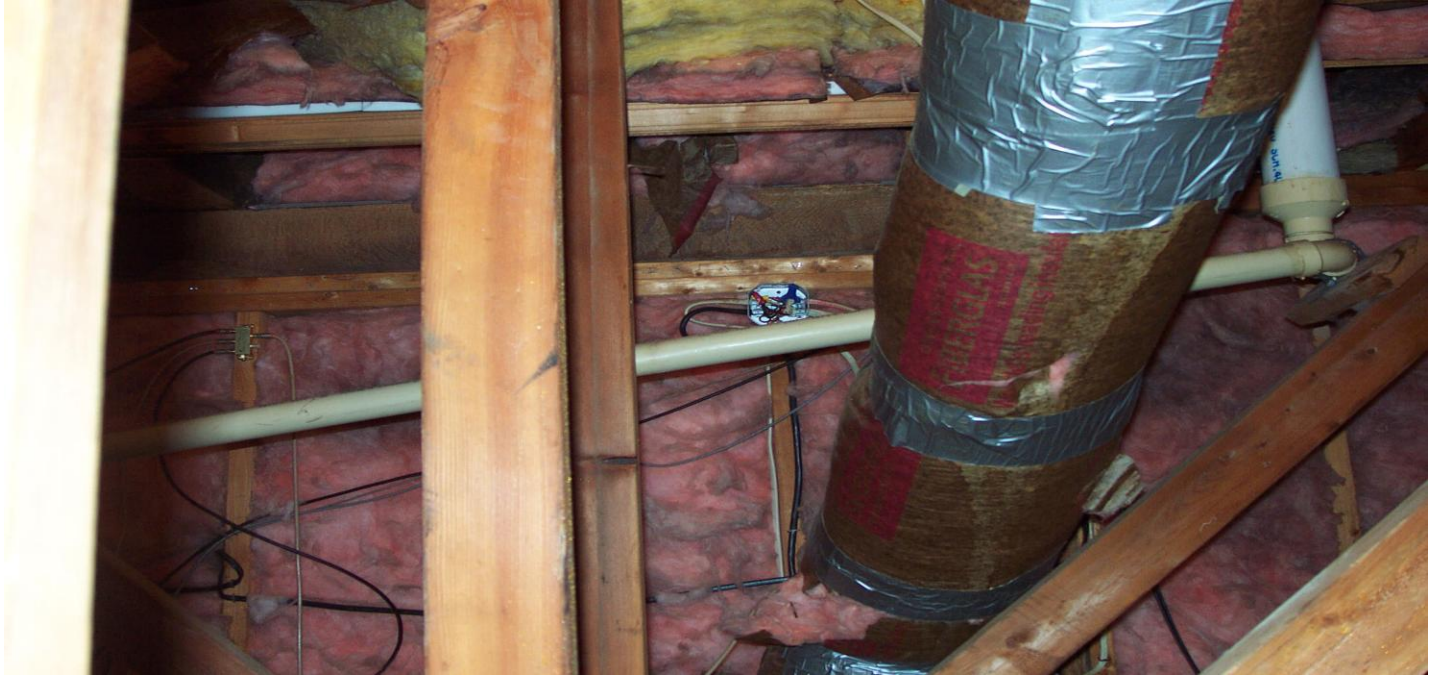
**Observations:** **One electrical box seen from garage access was missing a cover. Otherwise no problems were noted.**

**This electrical box in attic needs of cover. As seen from garage attic access.**

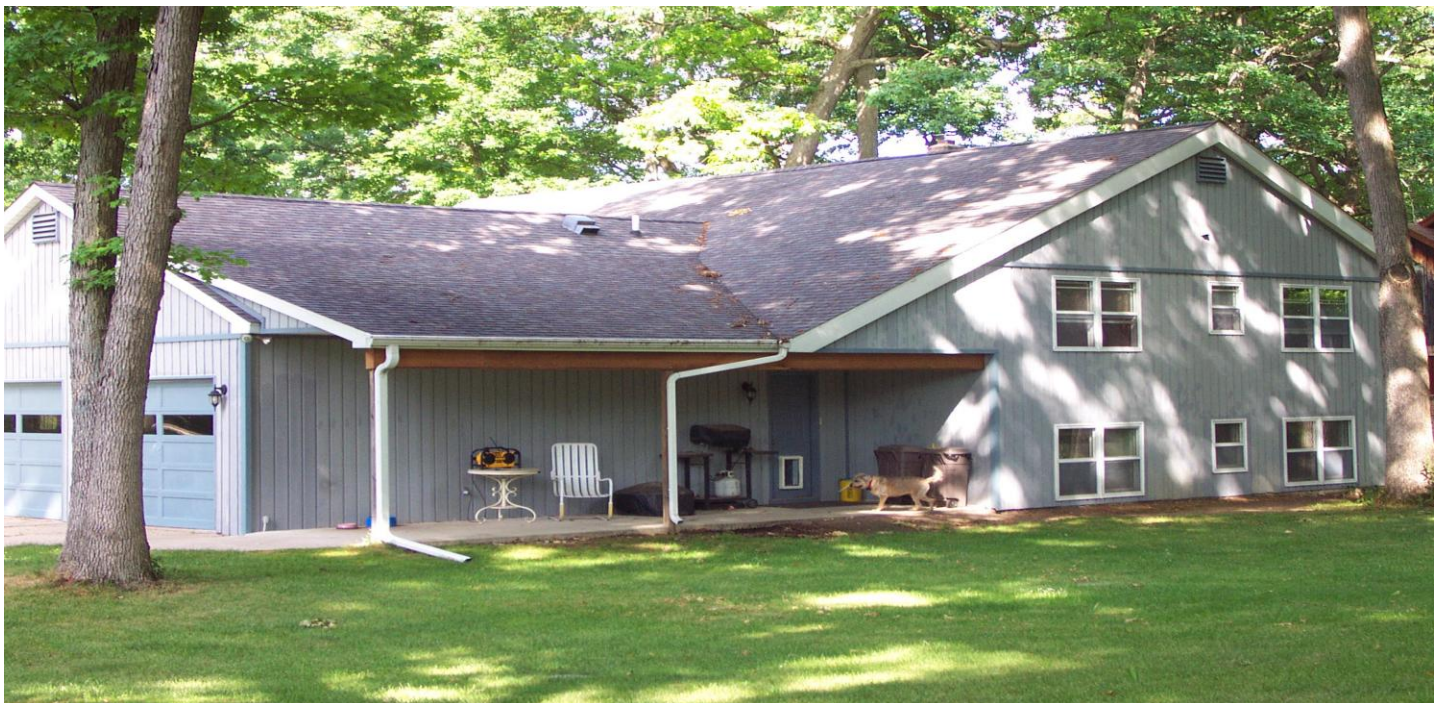
**Observations:** Newer seamless gutters and down spouts were present on home. Some tied into unground tile while others had had runoff piped away from home with one exception; one rear downspout was draining next to patio. This condition needs to be fixed to prevent water from accumulating near home.

**Rear view showing missing down spout extension.**

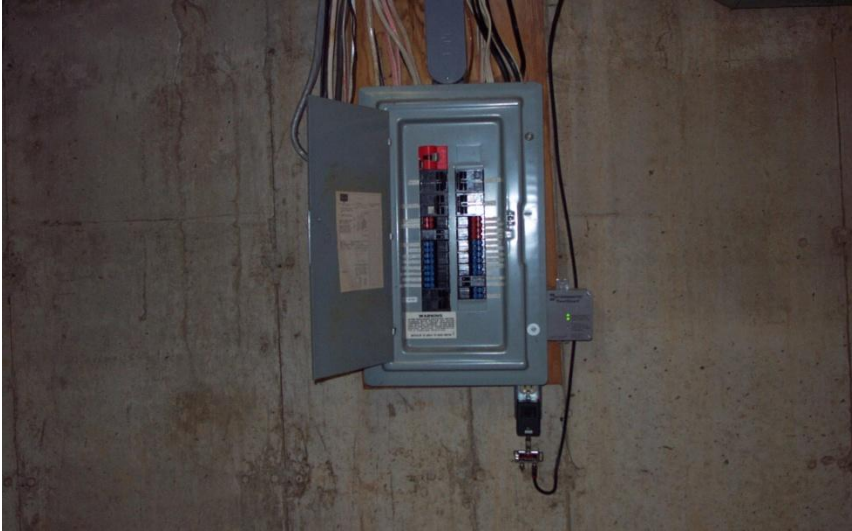
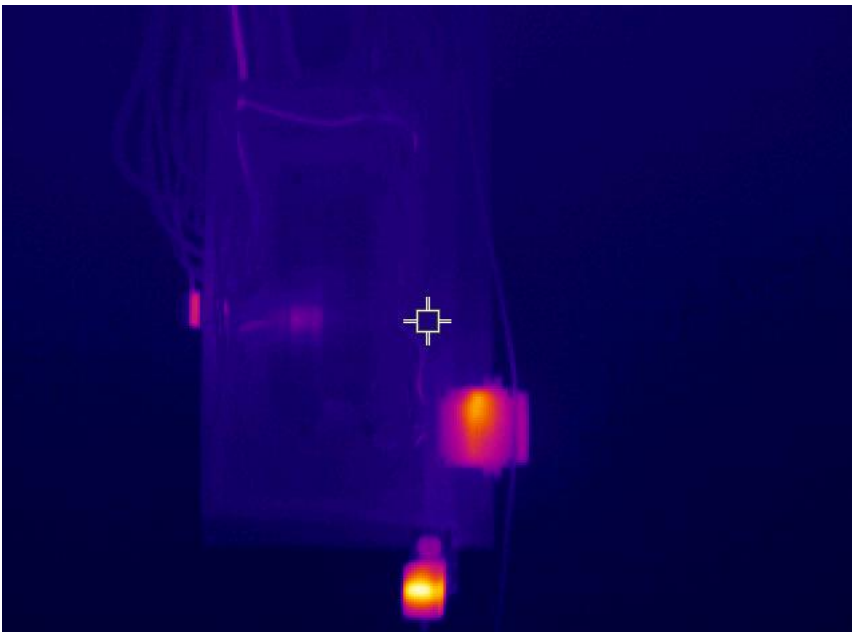
**Infrared picture below is of the service panel above. The orange and red seen in the picture are normal heating. No hotspots were found inside the service panel. No problems were found elsewhere in home as a result of infrared scan.**
